POTOMAC RIVER BASIN

THOMAS W. KOON DAM

INVENTORY NUMBER NDS 240

PHASE I INSPECTION REPORT

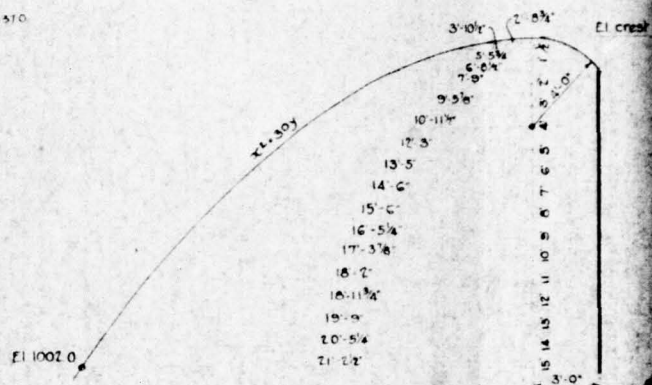
SHAPE OF CREST
Scale 1/8"=1'-0"

It was noted that the ogee spillway crest is obstructed by the remains of a former flashboard installation. These consist of horizontal 3-inch x 8-inch planks bolted to the crest and vertical steel pins set in holes in the spillway crest. These items catch drift and lessen the hydraulic efficiency of the spillway. It is recommended that they be removed.

1. The flashboard base and pins on the spillway crest should be removed immediately.
2. Additional hydraulic studies should be performed to ascertain the adequacy of the spillway and to determine maximum expected pool level.
3. Structural stability should be investigated based on the hydraulic studies.
4. Further studies should be initiated to determine the cause of leakage adjacent to the spillway abutments and to investigate the possible danger to the structural integrity in case of a high pool level.
5. The cause of settlement on the eastern roadway slab should be determined and corrected.
